## Lime finishes: what's the point? Pressure difference in storm conditions in a changing climate

Tim Meek<sup>1\*</sup>, Kate North<sup>1</sup>, C. Douglas Moore<sup>1,2</sup>

Meek T, North K, Moore CD, Subke JA. Lime finishes: what's the point? Pressure difference in storm conditions in a changing climate. *UCL Open: Environment*. 2026;(8):7. Available from: <https://doi.org/10.14324/111.444/ucloe.3623>

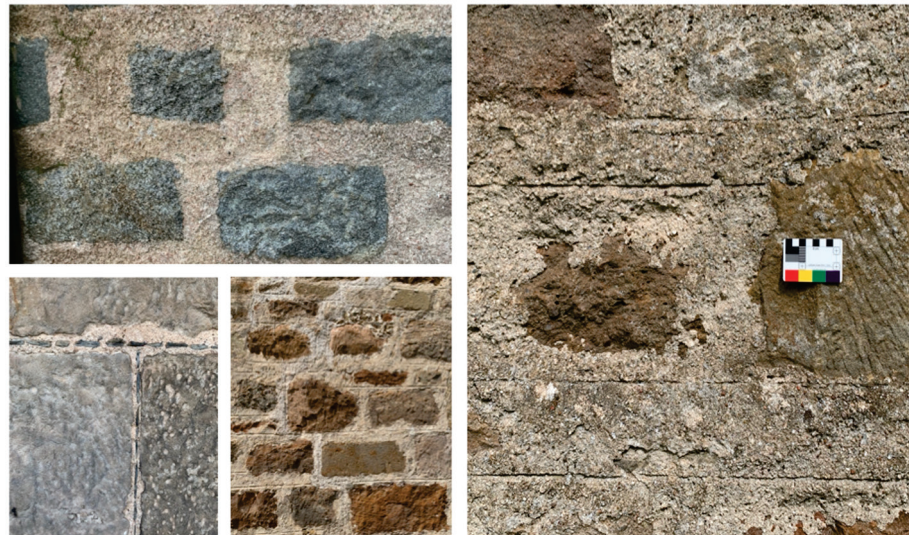
Figure 1

Some examples of the 16 Scottish lime pointing styles c. 18th–19th century.

Scotland was found to have 16 distinct pointing styles, with the overwhelming commonalities being lining-out: the pressing of mortar while still green, using a purpose-made tool. All the examples were at least flush with the face of the wall and in most examples completely covered the joint (Fig. 1). No evidence was identified in the archaeological record for the now ubiquitous 'heritage joint' (Gerard Lynch, personal communication). This method involves filling open joints with new lime mortar and then recessing them with a stiff brush, clearly defining the stone edges and exposing aggregate to produce an artificially aged appearance (Fig. 2). The heritage joint emerged in the early 20th century as a technique for the conservation of ruins and was later adopted for roofed buildings [11], a practice that has continued since.

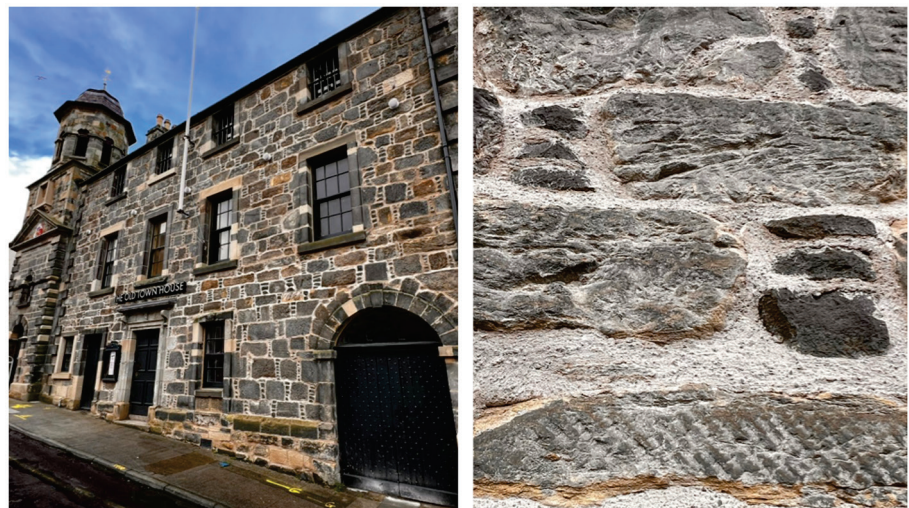
Figure 2

Inverkeithing Town House c. 18th century, an example of the 'heritage joint'.

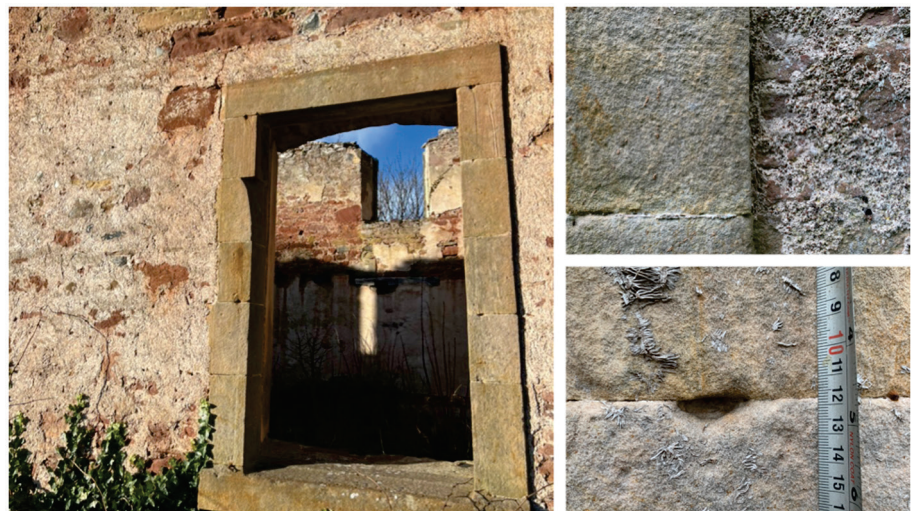
Figure 6

Left: An example of a raised margin and the relationship between the sill and the lintel. Right: Examples of the fineness of the joints between each of the stones that form the margin.

raised margins with very fine joints and little tolerance for adjustment were introduced in the late 17th century (Fig. 6). Masons were required to place the sill on padstones located to the left and right of the window opening, to ensure that the sill was placed and remained level and in the exact plane of the wall necessary to accommodate the margins. The padstones might have been as small as a single piece of slate or a larger profiled section of sandstone (Fig. 7). The accumulated compressive load of the margins was therefore transferred to the padstones. In this scenario, the under-sill joint and the masonry below the sill was not under compression, because the rubble stone was slotted in from the face of the wall, rather than built from above. The under-sill area was

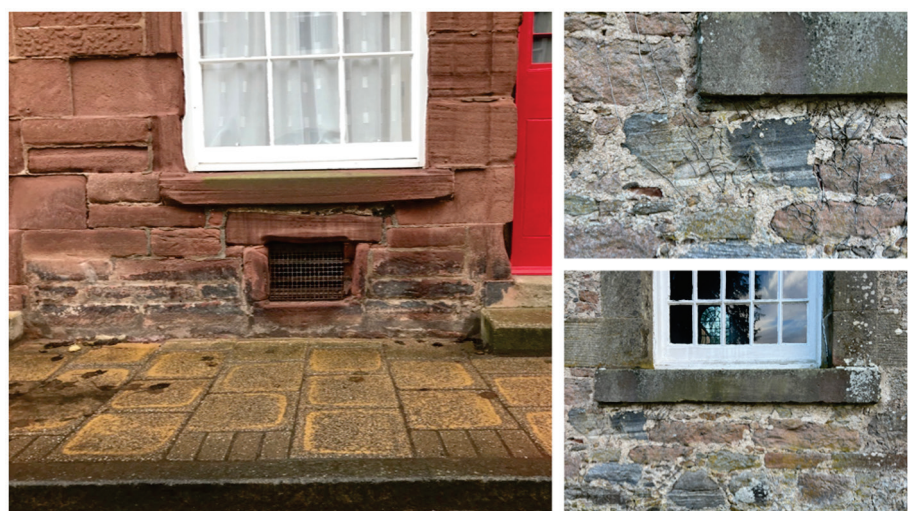
Figure 7

Examples of how the sill was supported on padstones.

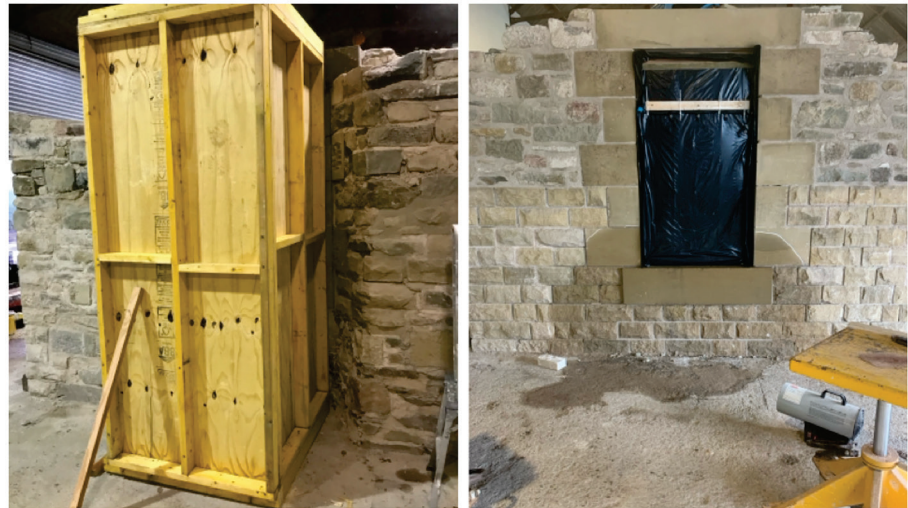
Figure 9

Left: The rear, 'interior' of the wall located within the window embrasure.  
Right: The 'exterior' of the wall.

An experimental sealed chamber was constructed off site, then installed within a simulated window embrasure constructed of Dunaverig Old Red Sandstone wall measuring height (H) 2.3 m × width (W) 0.6 m at the SLCT. The total wall length was 3.6 m. A pressure difference across the window embrasure was created by extracting air from the chamber to create specific internal/external pressure differentials in accordance with the British Standard BS EN 13829-2001 ‘Thermal performance of buildings – determination of air permeability of buildings – fan pressurization method’. The method was scaled down and substituted with an industrial dust extractor, which recreated the pressure differences defined in the British Standard above. The construction and installation of the chamber, and all the building and associated lime work, were undertaken by the first author, who is suitably qualified and experienced. During construction, the side, floor and roof panels of the chamber were glued and screwed together. Prior to installation, the masonry was tooled flush internally to accommodate the chamber. The open face of the chamber was scribed to the profile of flattened masonry. Discrepancies between the open face of the chamber and masonry were subsequently filled with polyurethane expanding foam to ensure an airtight fit between the wall and the chamber (Fig. 9).

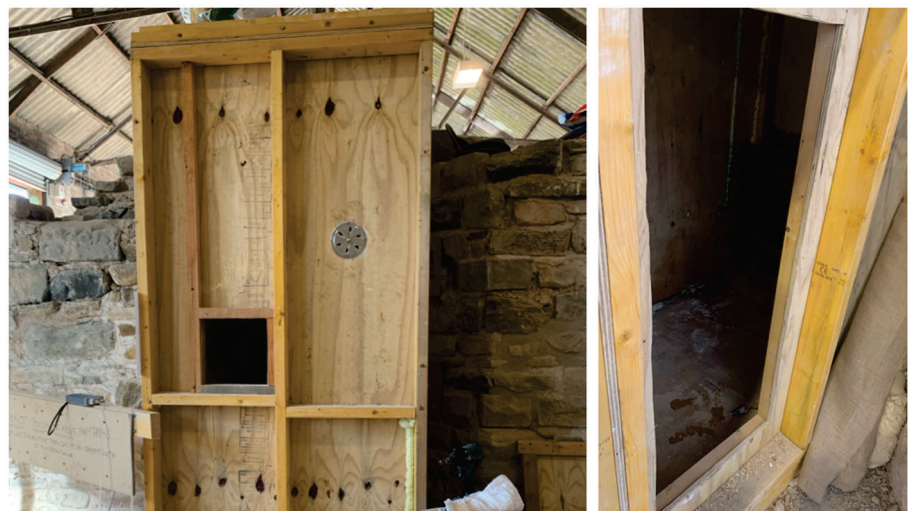
Figure 10

Left: The rear of the chamber with glazed viewing port, sliding vent.  
Right: Access to the chamber via demountable side panel.

The downscaled BDT pressure difference was created using an SIP 1.5 industrial dust extractor, collection volume 183 m<sup>3</sup>/h, motor: 230 V~50 Hz 1100 W (SIP Industrial Products, Shepshed, Loughborough, UK). This was permanently housed on one of the sides of the chamber (rear left) and fenced off for the duration of the experiments. The pressure was monitored with a calibrated digital manometer (Comark C9500, Fluke Precision Measurements Ltd, Norwich, UK), to assess actual pressure differences between the external environment and the interior of the chamber. The manometer expressed pressure differentials at 10 Pa intervals. The pressure was regulated within the chamber using a sliding vent that reduced or increased the pressure difference, dependant on the differences required, and the prevailing atmospheric conditions within the SLCT workshop. The chamber was provided with a glazed port at the rear for in-trial observations and a demountable side panel for access between pressurised runs (Fig. 10).

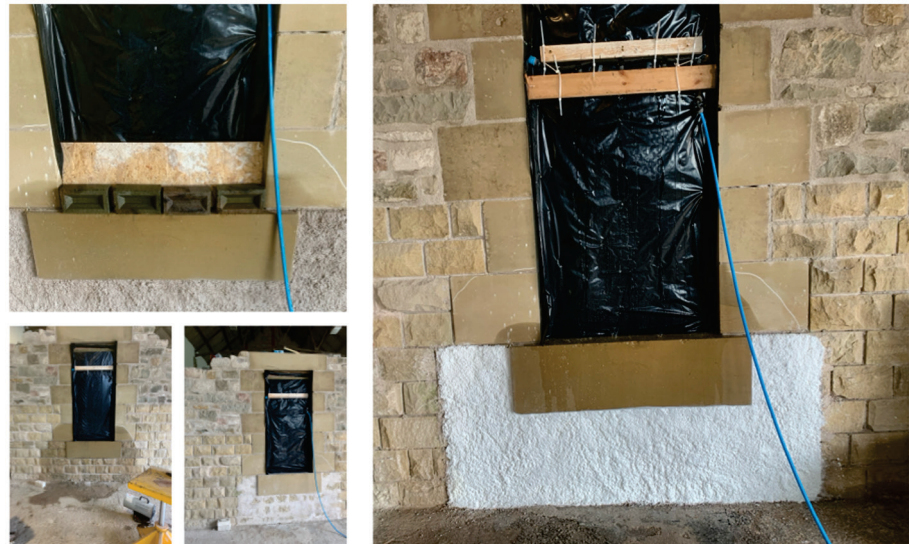
**Figure 11**

Top left: Under-sill area with harl. Right: harl and limewash. Lower central: Sneck harl application. Lower left: The heritage joint application.

Harl was applied in two coats at c. 10 mm, with sufficient time between applications for the mortar to 'firm up', but remain 'leathery', meaning that it was no longer a semi-liquid but still malleable enough to mould. The sneck harl was applied as a single coat of c. 10 mm thickness (Fig. 11).

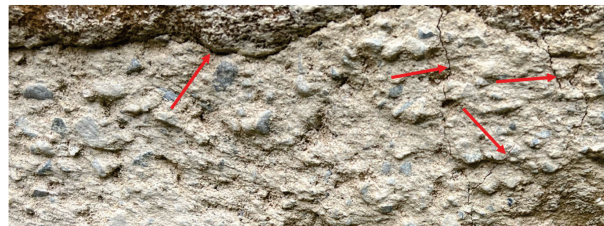
Figure 16

HMM shrinkage cracks indicated by the red arrows.

[35], but can be explained by the observations made before and during the pressurised runs. High calcium, high binder content mortars are prone to shrinkage as they cure [36], and if the mortar remains 'plastic' the process of shrinkage continues. The HMM mortars showed visible shrinkage cracks at all stages: building, sneck harl and harl.
